**FOURTH FIVE-YEAR REVIEW REPORT FOR
PORTLAND CEMENT SUPERFUND SITE
SALT LAKE COUNTY, UTAH**

**Utah Department of Environmental Quality
Division of Environmental Response and Remediation**

**U.S. Environmental Protection Agency
Region 8
Denver, Colorado**

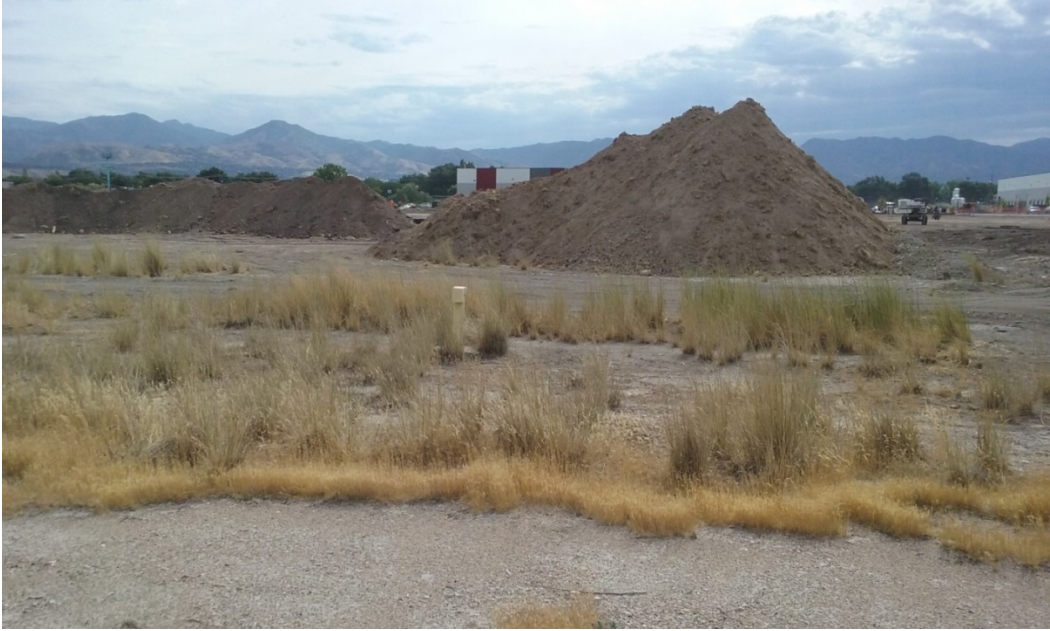
| Photo No. 1 | Date: 7/19/17 | | |

| Well P3CC, looking east, Redwood Depot Development in background | | | |

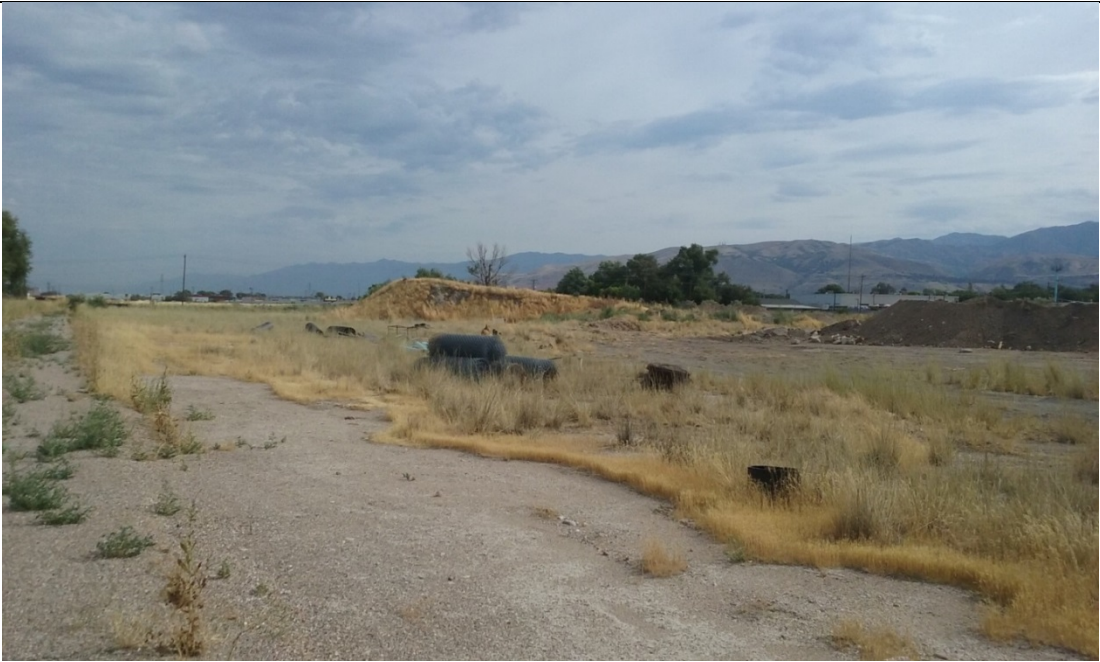
| Photo No. 2 | Date: 7/19/17 | | |

| Well P3CC, Looking north | | | |
